HOME INSPECTION REPORT

123 Main Street
Charlotte, NC 28216

Inspection date: 8/26/2009

South Charlotte Inspection Services, Inc.

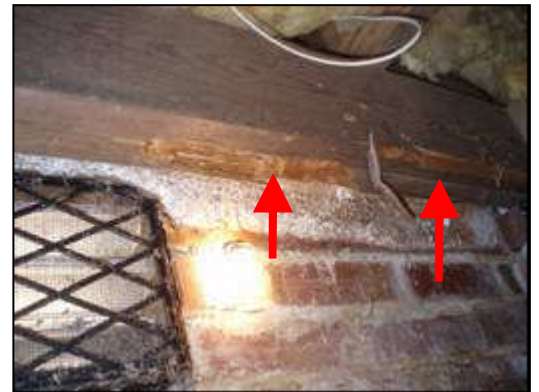
Sections of the drop girder along the rear of the crawlspace have been replaced. The boards at the rear of the new drop girder appeared to be spliced near the sides of the piers but do not bear directly on the pier. The ends of all floor framing member are required to be supported. A licensed contractor should evaluate how the sections of the drop girders are supported and to make necessary repairs. See left photo.

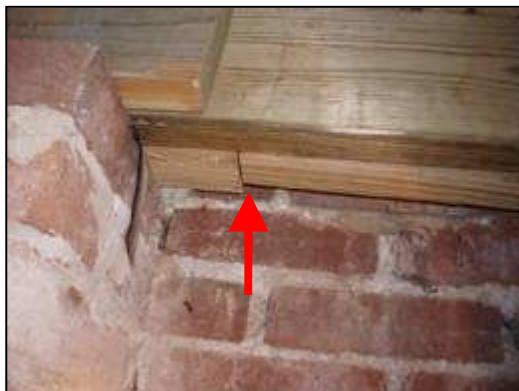
5. Deterioration was found in a section of the drop girder beam in the crawlspace near the rear left corner of the dining room. The drop girder is used to support the floor joist. The damage should be replaced as needed by a licensed contractor. See right photo.

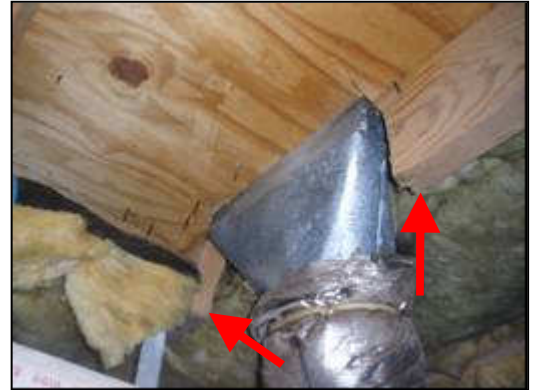
A floor joist has been cut in half to make room for a floor register in the crawlspace under the front of the kitchen. Although the floor joist may have been cut when the house was constructed, the ends of the floor joist should be properly supported. The floor joist should be repaired / replaced as needed by a licensed contractor. See right photo.

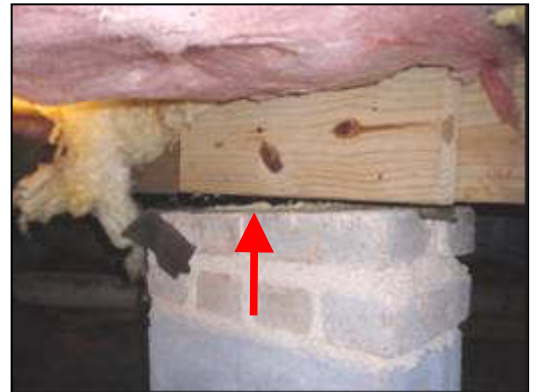
A gap was noted between a section of the drop girder beam and the top of a pier in the crawlspace at the front of the master bedroom. The bottom of the drop girder should be shimmed to contact the top of the pier. See left photo.

The ground in the crawlspace has sunken several inches under the master bathroom. It was reported that the foundation has been previously repaired by a foundation specialist under the supervision of an engineer. A metal post viewed through an open crevasse is believed to be part of a helical pier.

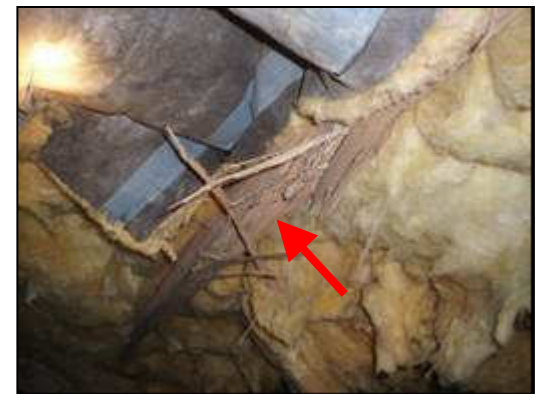
Termite damage was found in the full length of a floor joist in the crawlspace under the left side of the living room. A new full length joist should be installed next to the damaged floor joist. Termite tubes were noted in the sub-flooring and floor framing under the rear left bedroom. Random probing of floor framing members did not reveal only surface damage but areas of damage could exist. See right photo.

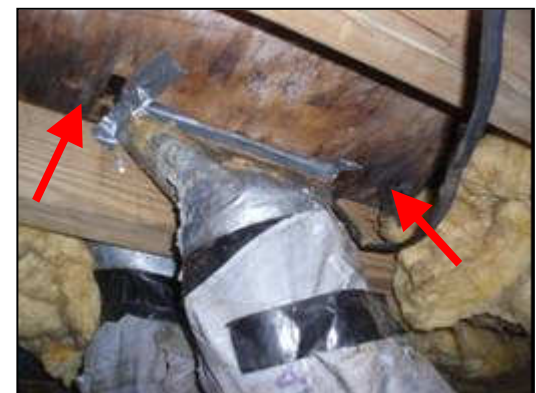
Deterioration was noted in a small area of sub-flooring around two floor registers in the crawlspace between the dining room and living room. The deterioration is believed to have been caused by moisture condensing on the floor register boots when the cooling system is operating. Sealing the registers to the sub-flooring and properly covering the registers with jacketing and floor insulation can help in reducing condensation. The sub-flooring around other registers should also be checked for deterioration at the time of repairs. See right photo.

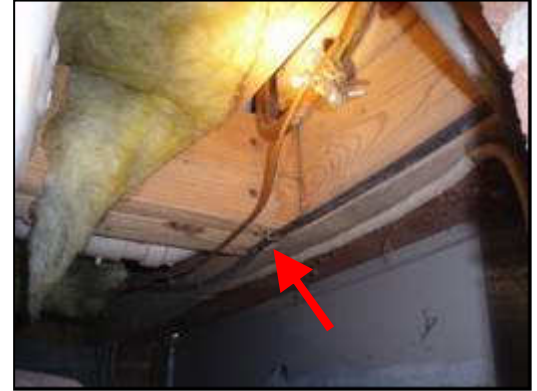
The ends of the drop girder center beams in the crawlspace at the left side of the breakfast room, at the front of the fireplace, and along the right side of the front left bedroom are toe nailed in place. The proper method of supporting the beams would have been to install a ledger board under the end of the beams or the beams could have been supported with metal hangers. See right photo.

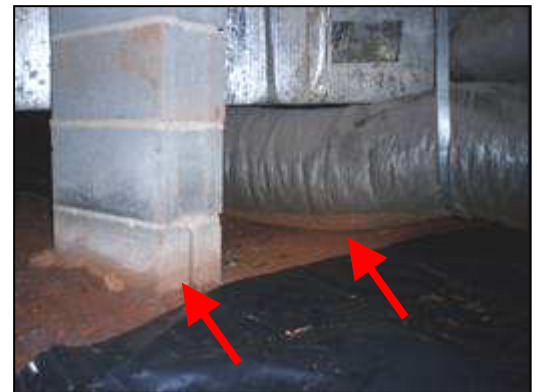
6. Mud stains on the bottom of the piers and ducting under the breakfast room is evidence of past water infiltration. The bottoms of floor framing members are stained and areas of deterioration were noted under the dining room and living room. Over time, water in the crawlspace can cause moisture related damage to the wooden members and is conducive to wood destroying pests. Moisture levels taken from various wooden members under the front bedrooms were 22% and staining was noted on the floor framing members at the front right corner of the crawlspace. A moisture specialist should be contacted to further evaluate the crawlspace and recommend methods of reducing moisture levels. Overall, the ground in the crawlspace was dry at the time of the inspection. See right photo.

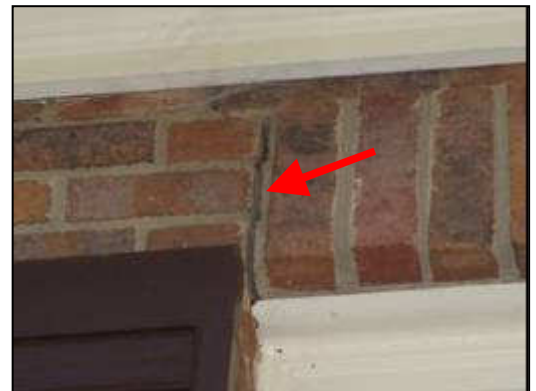
2. Stair stepping cracks were noted in the brick veneer in the following areas:

3/8" crack above the top left corner of the carport front left window, see right photo

Cracking is an indication of movement in the brick veneer siding and / or foundation. It was reported that the foundation at the rear right corner of the house has been previously repaired by a foundation specialist under the supervision of an engineer. Although the cracks are small at this time the size of the crack can progress and / or change seasonally over the life of the house. The cracks should be sealed, if possible, and monitored over time for movement.

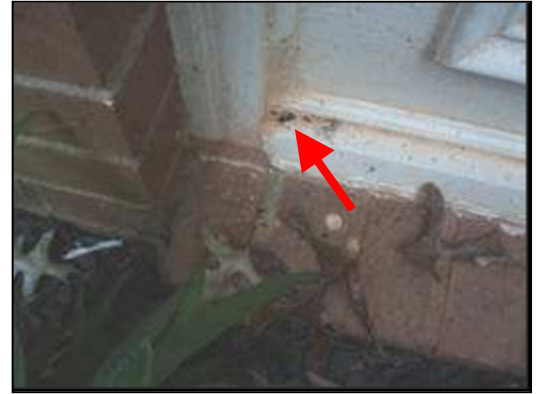
6. Decay was found in, but may not be limited to, the exterior trim in the following areas:

The fascia boards at the front right corner of the carport

Smaller areas of decay can be removed and patched with exterior type wood filler; larger areas of decayed wood should be replaced. An opening in the repaired fascia board at the rear left corner of the dining room should be sealed. Due to height constraints some areas of the exterior trim could not be accessed for evaluation.

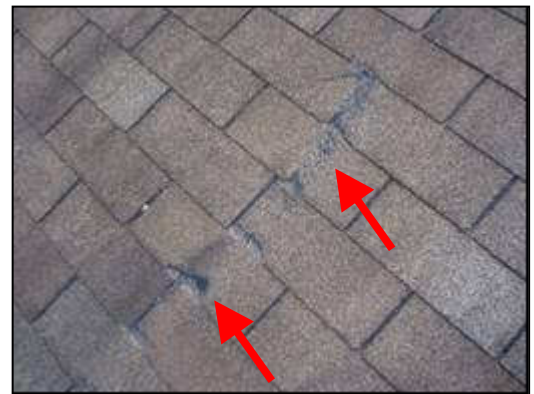
1. Damaged / torn shingle tabs were noted on the right roof near the rear corner, on the rear roof near the vent pipe, and on the front roof above the carport. Overall the roof seemed to be in good condition but the shingles should be checked for necessary repairs. See right photo.

Moss was noted growing on the surface of the roof at the front right and rear right corners of the house. The moss can damage the shingles over time and should be removed. An experienced pressure washer professional should be able to clean the roof without damaging the tabs.

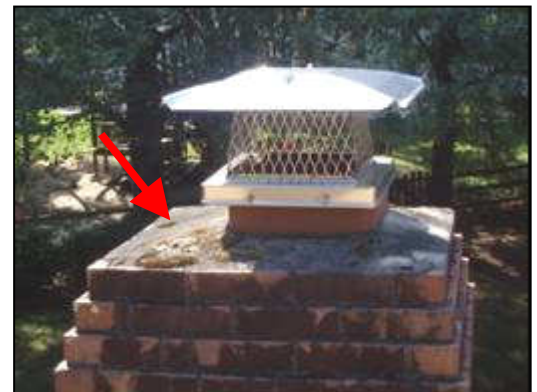
Masonry crown on top of the chimney is cracked, worn, and showing age. When this occurs, water seeping past the cracks can cause substantial damage to the masonry stack, as well as to the framing, walls and ceilings below. Crown and mortared joints should be re-pointed and sealed. See right photo.

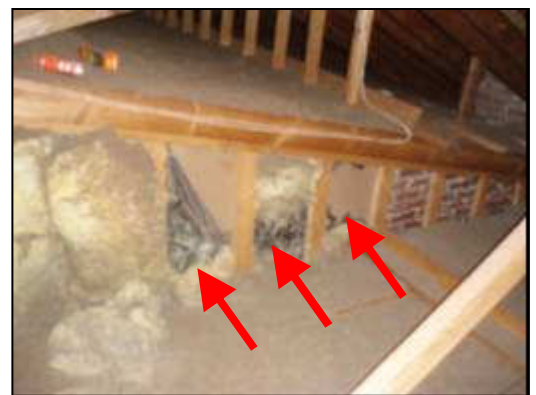
Insulation is missing / dislodged from the living room vaulted ceiling at the right side of the attic. See right photo

The attic side of the pull down stairs should be fully insulated. Pull down stairs can be the largest source of heat transfer between the house and attic.
